UTAH DOT BRIDGES GAPS IN SALT LAKE CITY I-80 BRIDGE APPROACHES WITH CRAFCO MASTIC

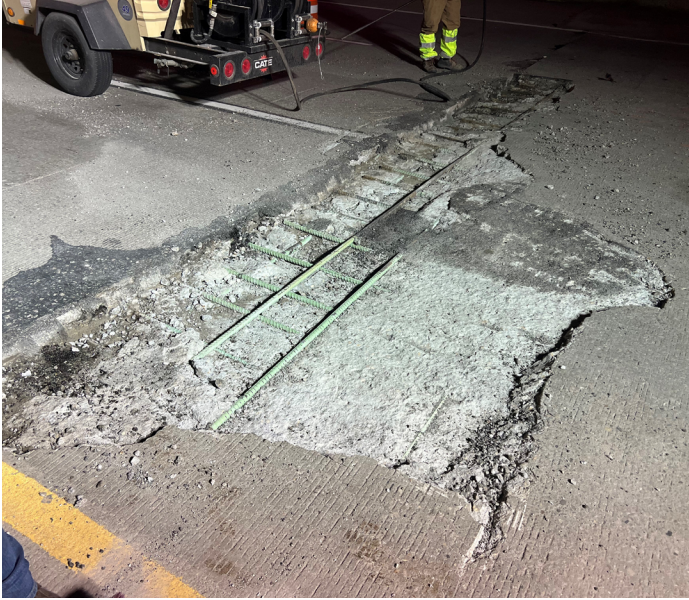
UDOT removing multiple existing patch repair materials and demolishing unsound concrete to ensure Mastic One material adheres to sound pavement.

"We started jackhammering out with the expectation of doing probably a 2-foot by 3-foot section," says Bob Giolas, supervisor at Salt Lake Station. "By the time we were done sounding, we actually went 5 feet wide by about 11 feet long. And then on lane two, we did a [section] 3 feet wide by 6 feet long, all tied into the same area."

“We purchased a full pallet and went through most of that,” Giolas says. “We had to do two lifts because everything in the No. 1 lane was a lot deeper than we expected. The No. 2 lane was pretty shallow; only maybe 2 inches deep, so that was part of our second lift.”

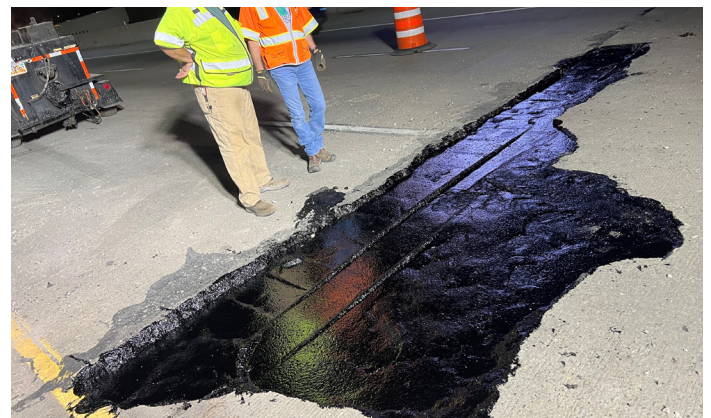
The first lift of Mastic One has been placed and is cooling before next and final lift to be installed. UDOT installed the Mastic One on all edges during the first lift to ensure a waterproof bond on all surface area of the repair.

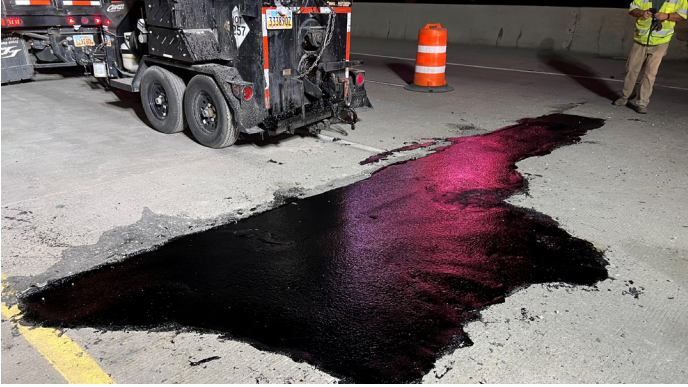
Second and final lift of Mastic One was installed added structure and stability back into the distress. The flowable characteristics provide smooth transition and improved safe driving experience.

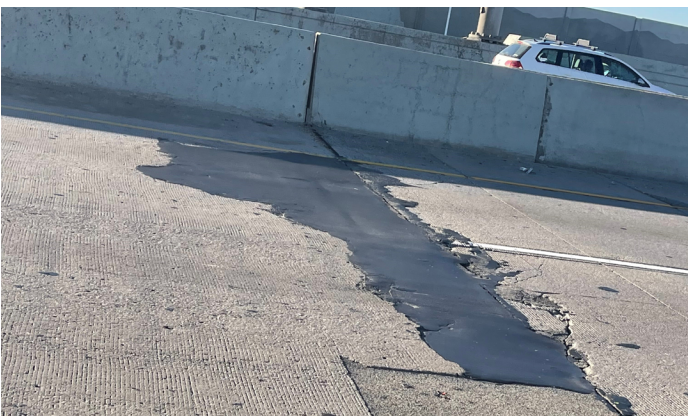
Roughly six months after it was applied, Mastic One is still providing I-80 drivers with a safe, smooth surface.

"It's holding up tremendously," Giolas says. "It's very smooth. We haven't had any complaints since then. I'm confident we can go all winter long and not have to worry about it. That's going to save so much time and labor on going out and fixing potholes. We got 11 pallets, and we plan on doing probably about 13 more bridge joints in our area."

Photo taken 6 months after application of Mastic One.
